## City of Santa Barbara: Mason, Chapala, and Cota Bridge Replacements

**Natural Environment Study**

December 2010

This report presents the biological findings and new project information for three bridge replacement locations along lower Mission Creek in the City of Santa Barbara, Santa Barbara County, California. This report is in response to the letter from Caltrans dated February 18, 2010 describing the reporting requirements for the project. The data provided herein and in the supporting Biological Assessment is intended to supplement the existing extensive documentation and information previously provided by the U.S. Army Corps of Engineers (USACE) to the U.S Fish and Wildlife Service (USFWS) and the National Marine Fisheries Service (NMFS) and through the CEQA review for the Lower Mission Creek Flood Control Project (LMCFCP). The proposed bridge replacements occur at Cota Street Bridge (No. 51C – 0246 / BRLO), Chapala Street Bridge (No.51C-0250 / BRLSZD - 5007 {043}) and Mason Street Bridge (No. 51C – 287) (the Site); locations are shown on Figure 1 (City of Santa Barbara Department of Public Works 2010a, 2010b, 2010c). The existing Cota and Mason Street Bridges are class

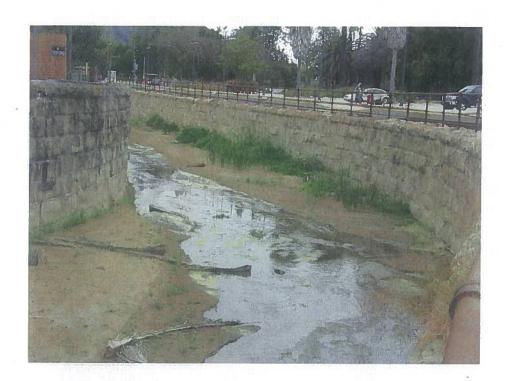
P7080543

Chapala Street Bridge site, looking upstream at sandy substrate and occasional native freshwater marsh species.

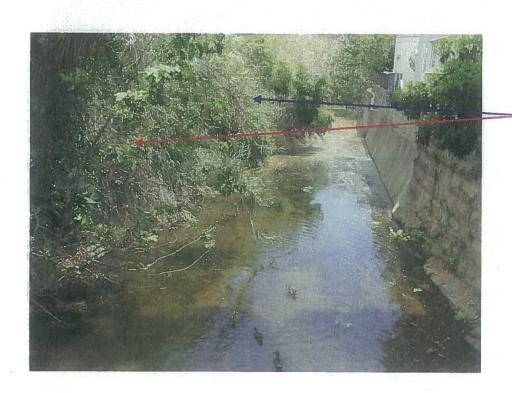
Chapala Street Bridge site, looking downstream. One native western sycamore is visible in this photograph (red arrow) along with dense stands of the invasive giant reed (blue arrow).

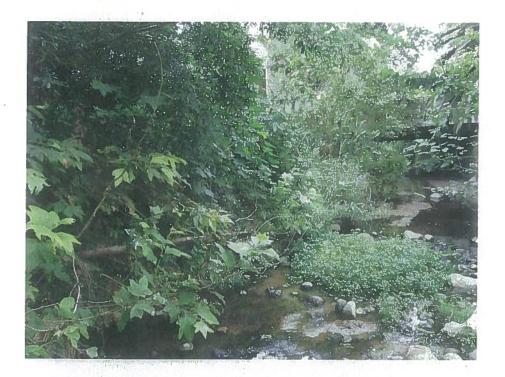
P7080525

Cota Street Bridge site, looking downstream towards bridge. This site supports a small fragment of mixed riparian forest dominated by western sycamore and arroyo willow along the margins, and freshwater marsh vegetation in the streambed.

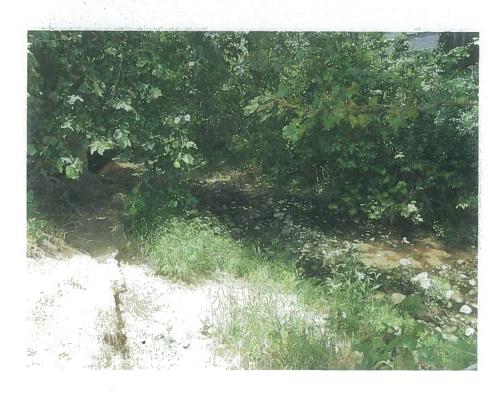
Cota Street Bridge site, looking upstream from annual grassland on west bank. This site supports mixed riparian forest dominated by western sycamore and arroyo willow along the margins, and freshwater marsh vegetation in the streambed.

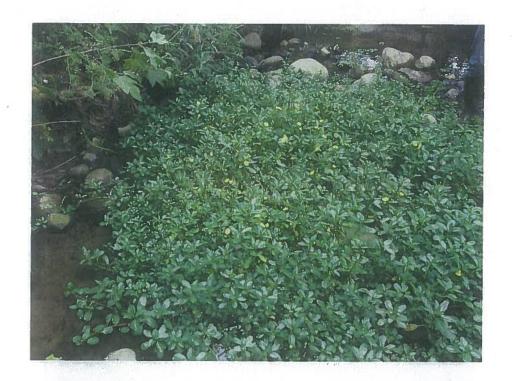
P7080501

Cota Street Bridge site. Yellow marsh-primrose is one of several native freshwater marsh species growing at this site.

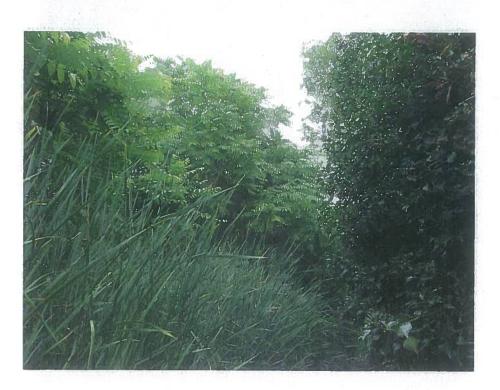
Cota Street Bridge site, looking downstream. Invasive English ivy on right and tree of heaven on left predominate, along with patches of native freshwater marsh species, such as the cattail in the foreground.

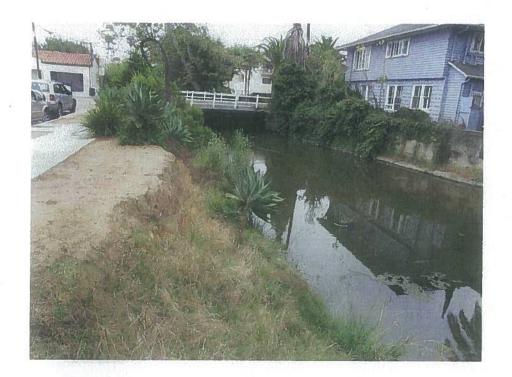
P7080580

Mason Street Bridge site, looking downstream towards bridge. Invasive English ivy grows over walls on right and a combination of non-native, native, and planted species occur on banks on left.

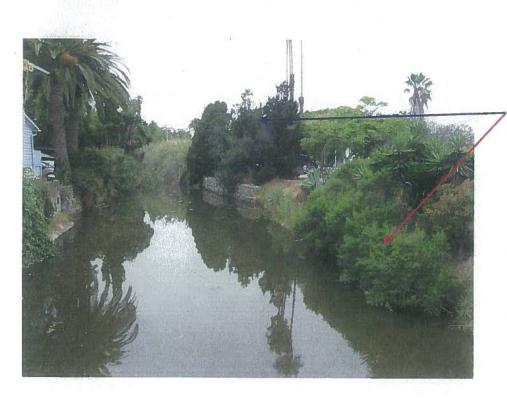
Mason Street Bridge site, looking upstream from bridge. Native coyote bush (red arrow) and oak trees (blue arrow) are visible in this photograph.

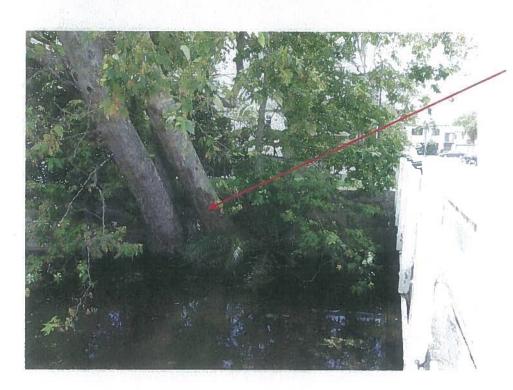
Mason Street Bridge site. A large multi-trunked western sycamore leans over the water immediately downstream from the bridge.
